PHOTOGRAPHIC INTERPRETATION REPORT

SOUTHEAST ASIA ACTIVITY REPORT

SELECTED TRANSPORTATION AND INFILTRATION COMPENDIUM

NPIC/R-119/67 JULY 1967

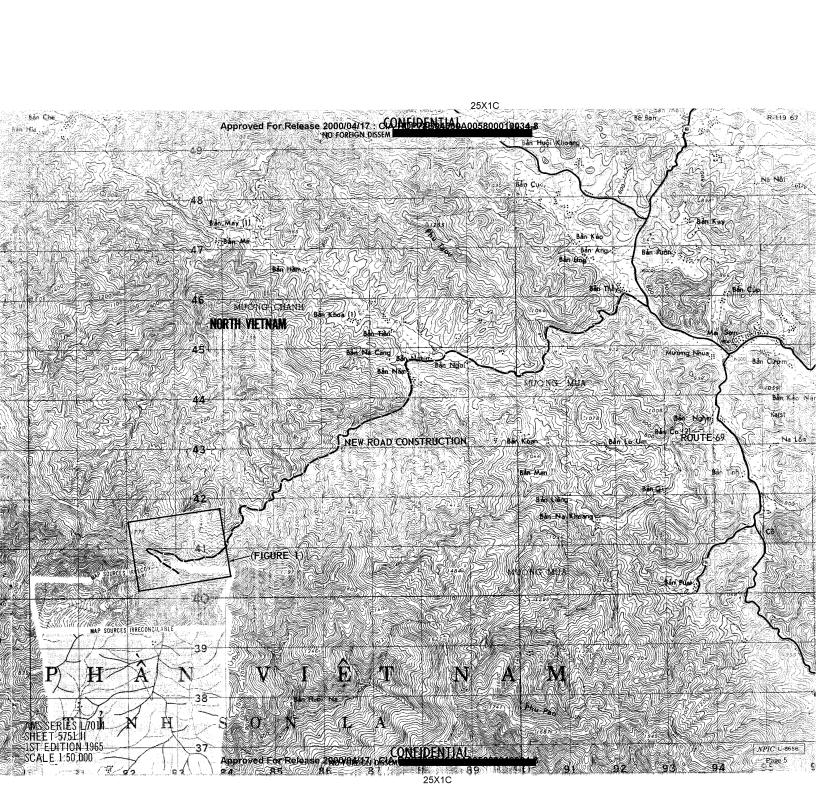
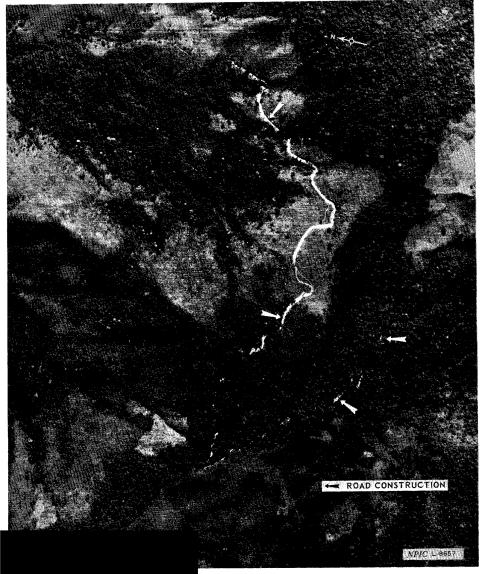
FIGURE 1. ROAD CONSTRUCTION, ROUTE 69 AREA, NORTH VIETNAM

A road in early-to-middle stages of construction is observed extending generally southwest from Route 69 at 21-12N 103-57E (UTM to the terminus of construction activity on a ridge at 21-09N 103-52E (Figure 1).

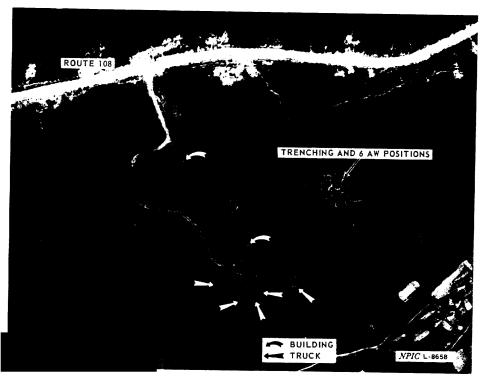
FIGURE 2. TRUCK PARK, ROUTE 108, NORTH VIETNAM

A truck park is located approximately 150 yards south of Route 108 at 17-57N 106-13E (UTM ______. Two buildings and five trucks are observed in the area (Figure 2). Trenching and six AW/AA positions are nearby at ______ Numerous other parking areas are observed along 25X1D 25X1D

this segment of Route 108, which is undergoing continued improvement.

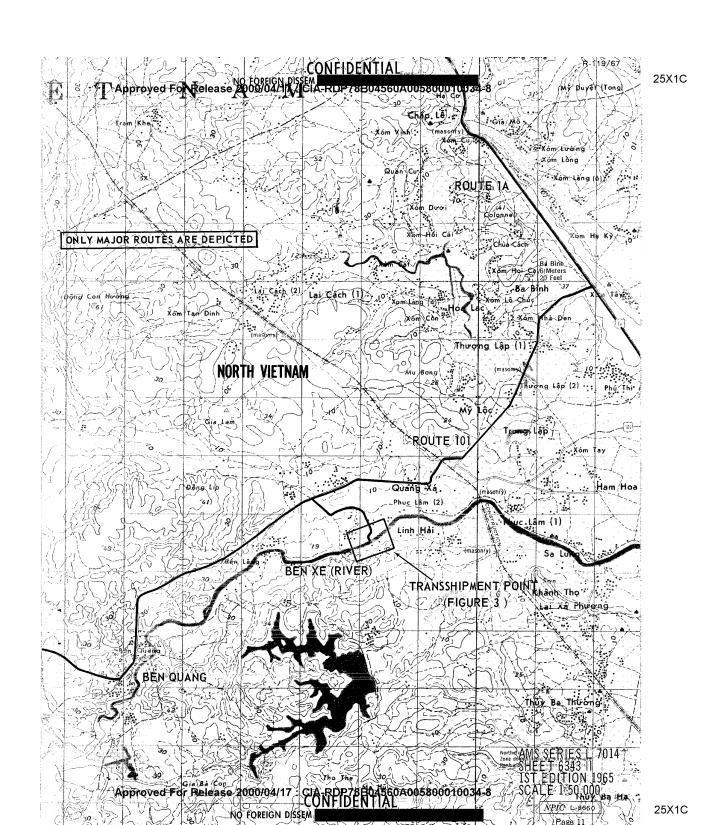
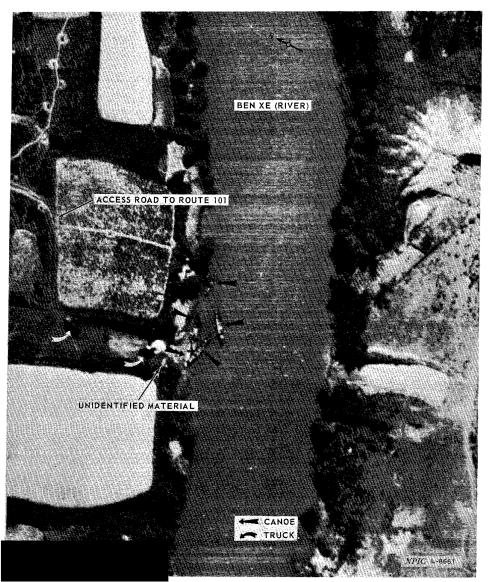
FIGURE 3 . TRANSSHIPMENT POINT, BEN XE (RIVER), NORTH VIETNAM

25X1D 25X1D 25X1D A small transshipment point is located on the northwest bank of the Ben Xe (River) at 17-02-10 106-57-10 E (UTM 1000-000), approximately 2.5 nm northeast of Ben Quang. An access road connects the area with Route 101 at 1000-000 Unidentified material is being unloaded from one of two trucks in the area and five large canoes are moored nearby (Figure 3).

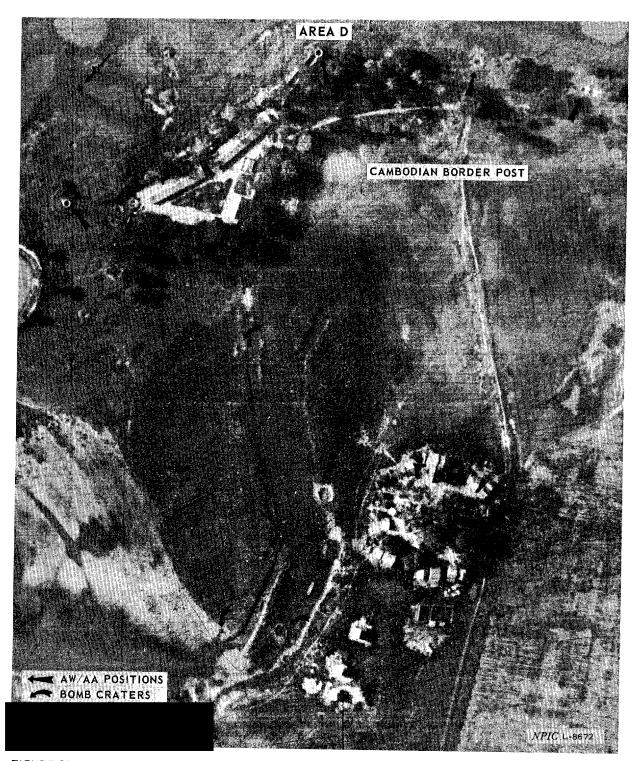
FIGURE 12. PROBABLE INSURGENT TRANSSHIPMENT AREA, CAMBODIA/SOUTH VIETNAM BORDER AREA

25X1D Six buildings located within a possible Cambodian border post at appear active; however, lack of vehicular access to this area and general deterioration of defenses may indicate the possible abandonment of this installation by Cambodian personnel (Figure 12).

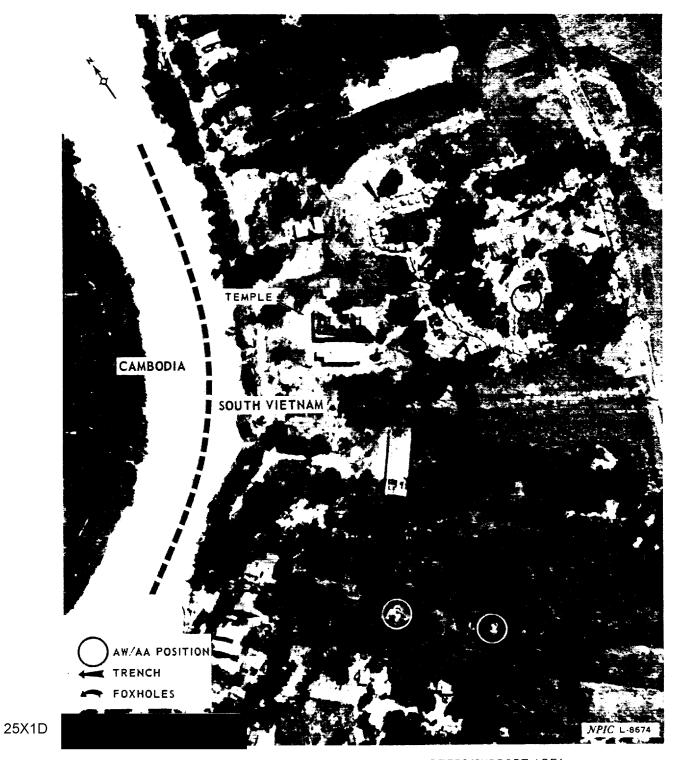
FIGURE 13. PROBABLE INSURGENT HEADQUARTERS/SUPPORT AREA, SOUTH VIETNAM/CAMBODIA BORDER AREA

25X1D of Ap II (inside South Vietnam approximately 200 yards east of the border, contains at least 4 large support buildings, 37 smaller support buildings, and 1 AW/AA position within a perimeter of trenches completely surrounding the area (Figure 13). Additional perimeter defenses include 2 possible AW/AA positions, immediately south at

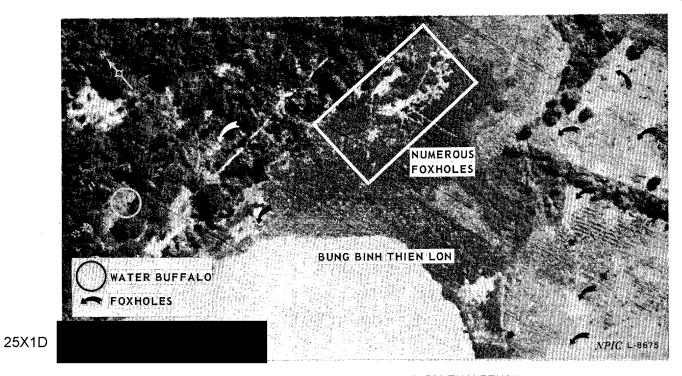
FIGURE 14. PERIMETER DEFENSES, SOUTH VIETNAM

25X1D (Figure 14) and northwest, inside Cambodia, at (Figure 18).

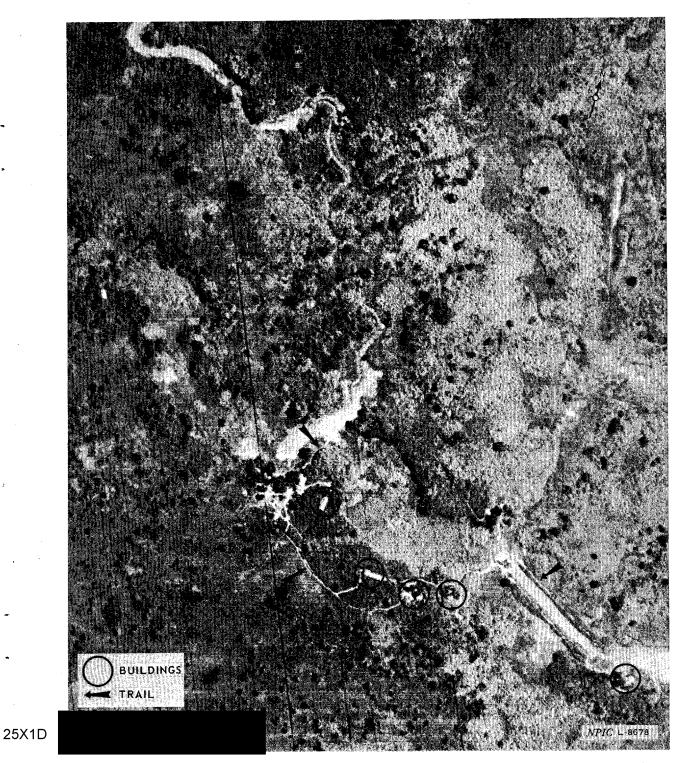
FIGURE 17. PROBABLE INSURGENT ENCAMPMENT, SOUTH VIETNAM/CAMBODIA BORDER AREA

A probable insurgent encampment at UTM contains at least 25X1D 5 buildings within a swampy area. Numerous trails extend east toward a probable headquarters/support area (Figure 17). A second probable encampment, approximately 1,200 yards northwest of the border at contains at least 2 buildings surrounded by foxholes, trenches, and has 4 AW/AA positions (Figure 19).

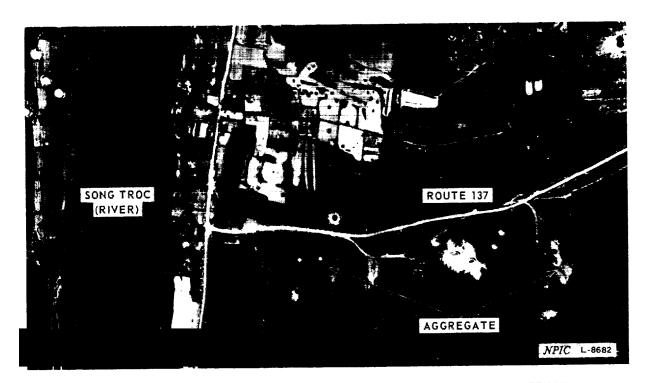
FIGURE 20. JUNCTION OF ROUTE 137 AND ROUTE 101 BY-PASS, NORTH VIETNAM

25X1D	1.	Aggregate Pits, short access road to each area (Figure 20).
25X1D	2.	· · ·
25X1D	3•	
23/11/10	J •	lanes (Figure 21).
25X1D	4.	Probable Rest and Refuel Area, at least 2 partially
		concealed buildings, heavy track activity under tree canopy, and an access road.
25X1D	5•	and an access road.
20, (12	→	
25X1D	6.	Truck Park, single loop road; single
25X1D	•	parking lane.
25X1D	7.	
20/(15		canopy, 0.5 nm access road (Figure 22).
05745	8.	Truck Park, single parking lane near stream.
25X1D	9.
